HO-979

William and Elizabeth Robinson House

3646 Fels Lane

Ellicott City

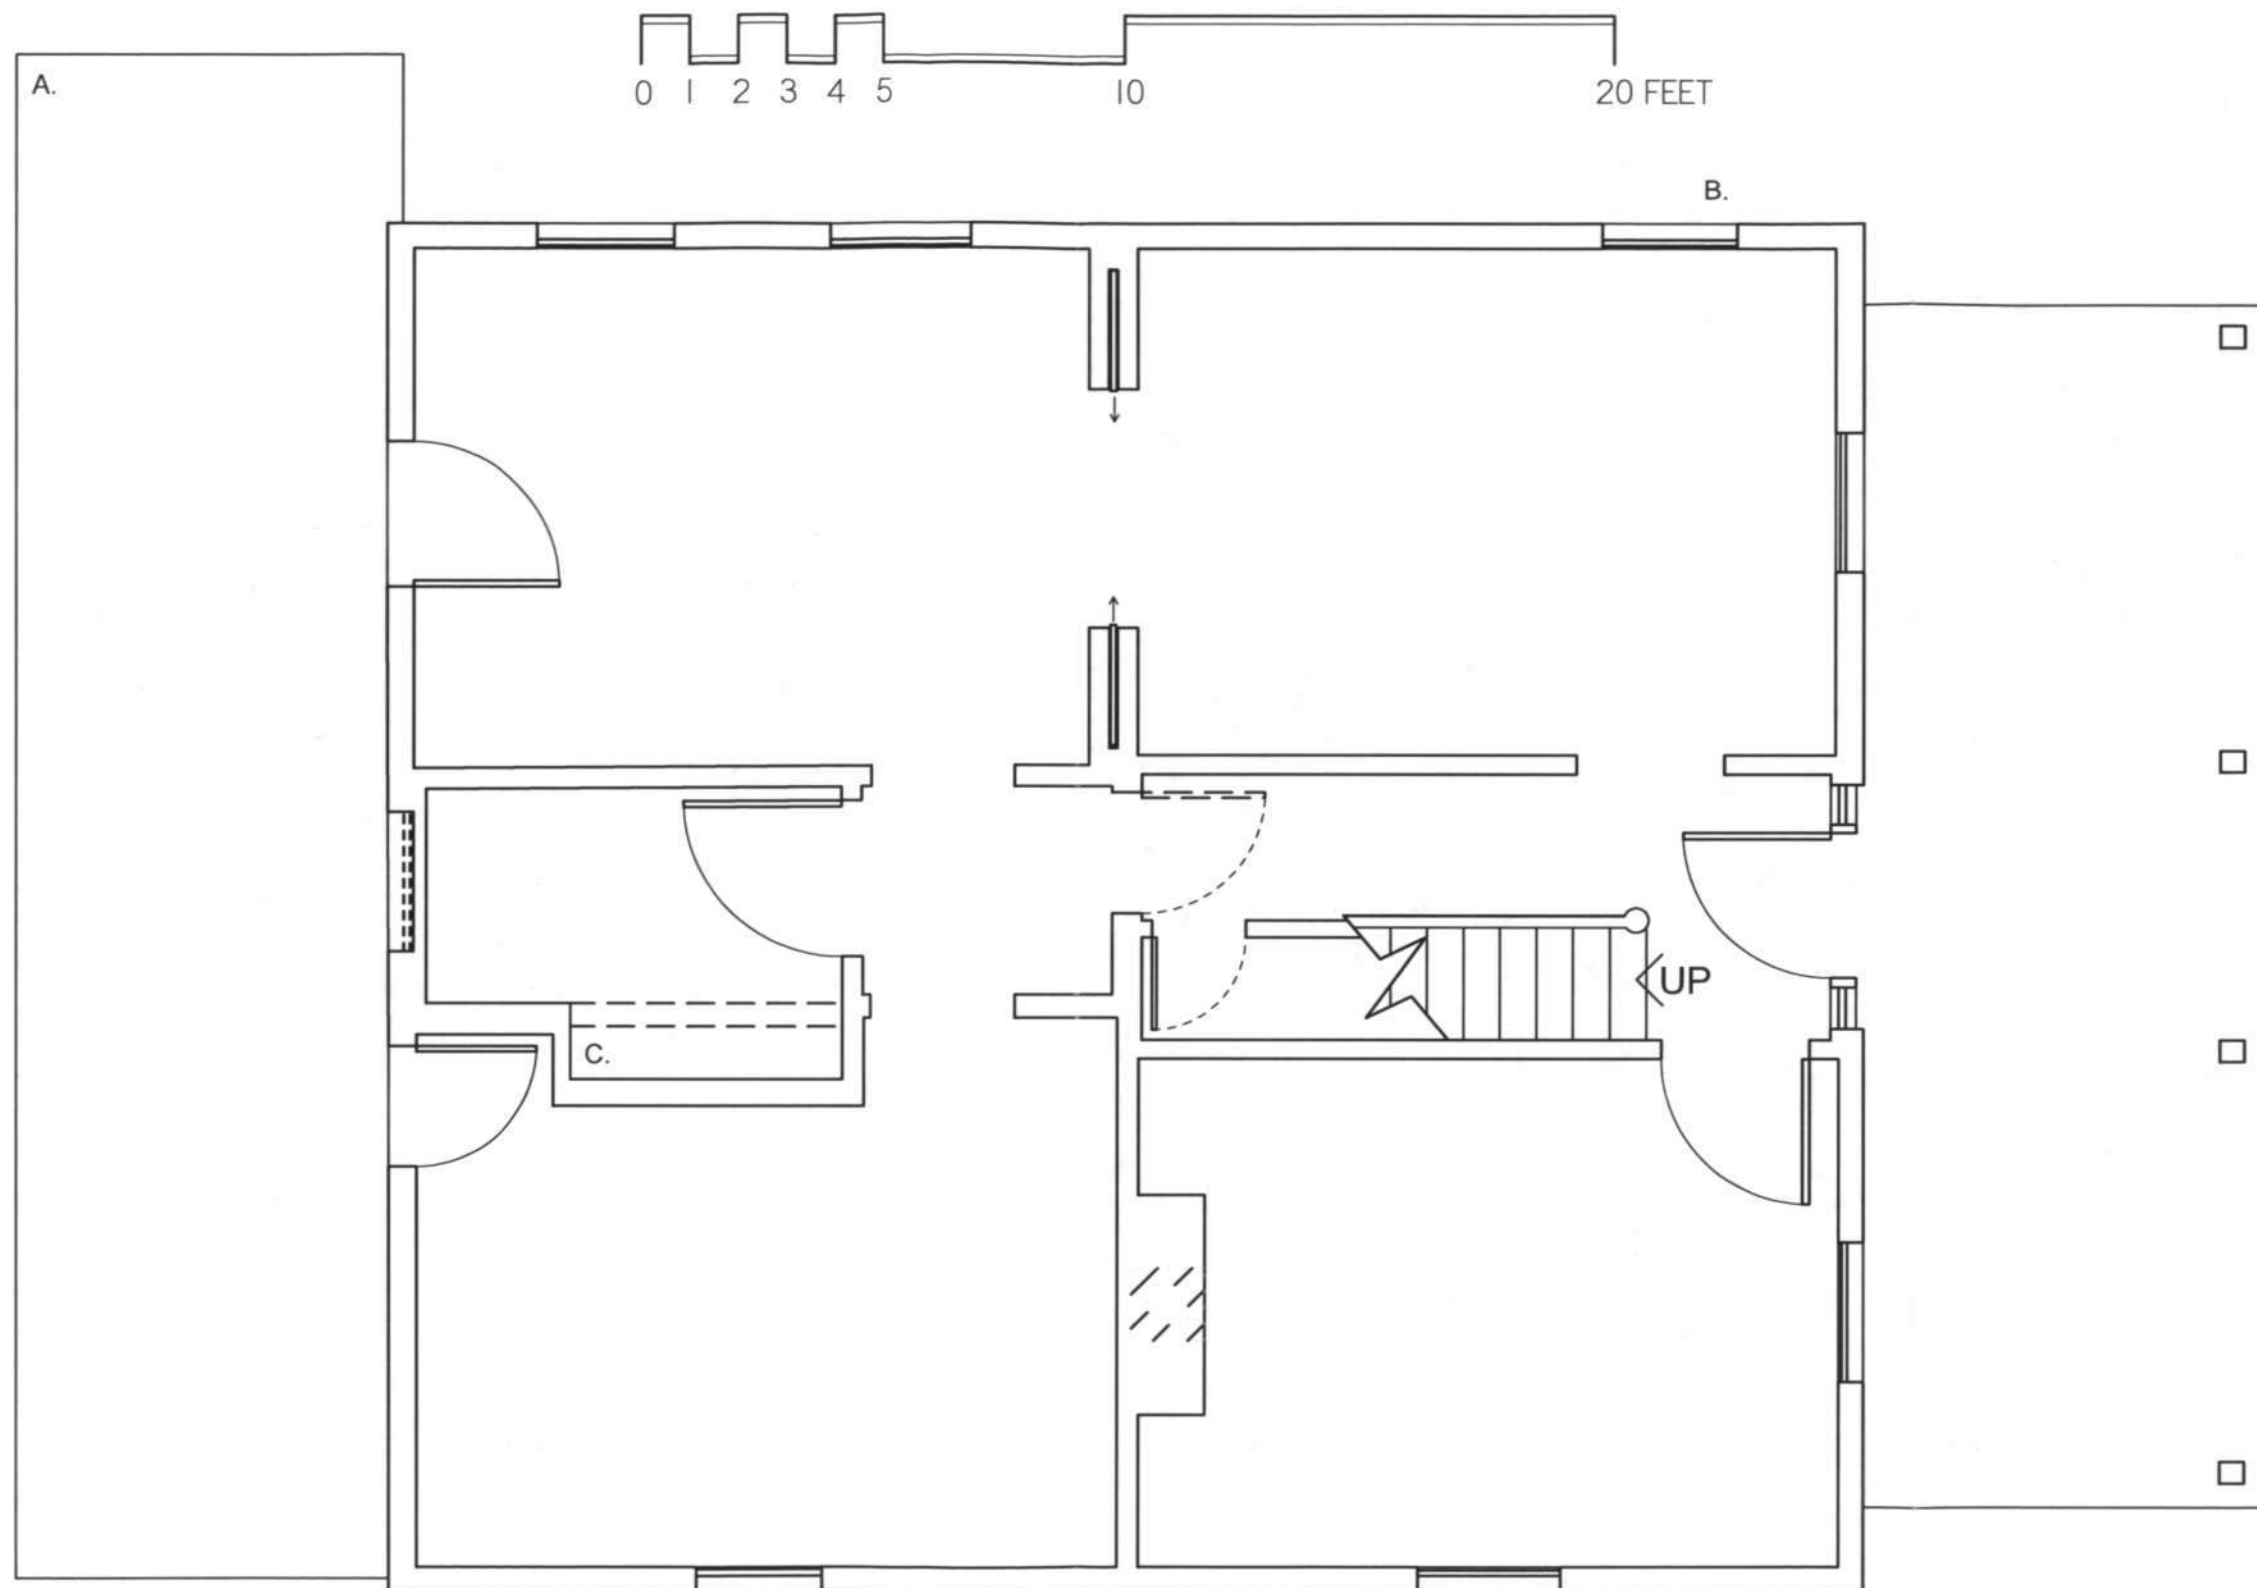
FIRST FLOOR PLAN -- MEASURED AND DRAWN BY KEN SHORT -- FEBRUARY 2009

A. PORCH NOW  
ENCLOSED --MODERN  
DETAILS NOT SHOWN.

B. MODERN SASH --  
OPENING PROBABLY  
MODERN.

C. WALL MOVED TO  
CREATE FULL BATH.

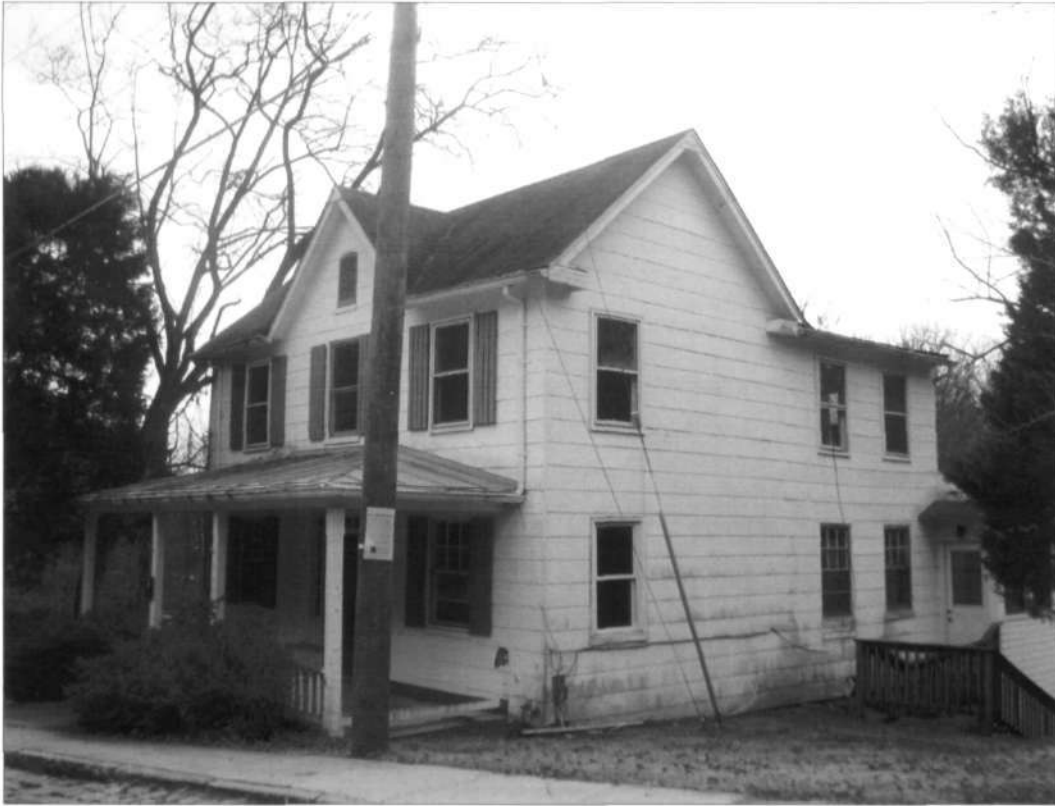
William and Elizabeth Robinson House  
3640 Fels Lane, Ellicott City (Lot is 3646)  
Photos by Jennifer K. Cosham, 12/5/2012  
North elevation

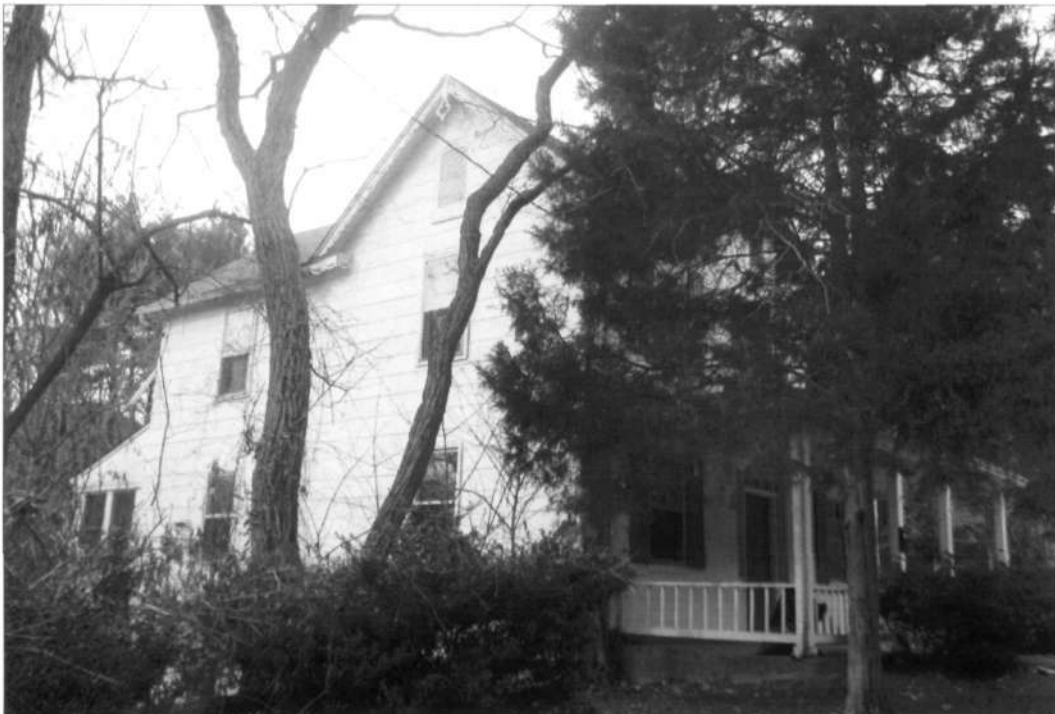
East elevation

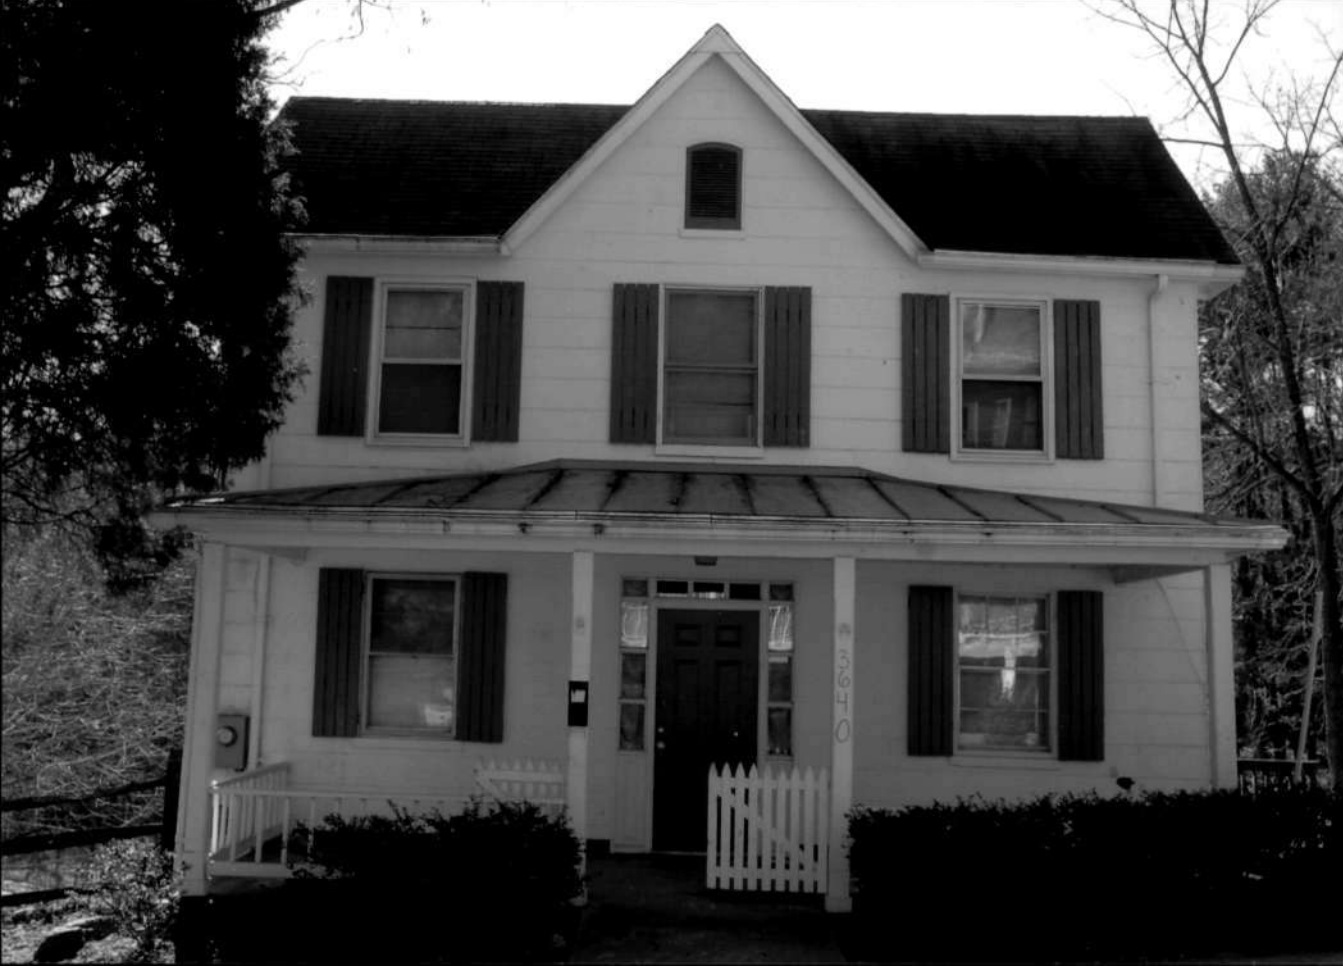
1 of 7

Northeast elevation

On the northeast elevation, the first story has a center entrance with a new steel six-panel door and new sidelights and transom, in a beaded-interior-edge frame. There is a six-over-one sash to each side with a beaded-interior-edge frame and fake board shutters. There is a one-story, three-bay porch that has a concrete deck, bead-board soffit, four chamfered posts, a hipped roof with standing-seam metal, and new pressure-treated wood railings. The second story has three one-over-one sash with the same frames and shutters as the first story. There is a segmentally-arched wood vent in the cross gable and a wood box cornice with returns. The northwest elevation, on the first story, has a one-over-one sash in a

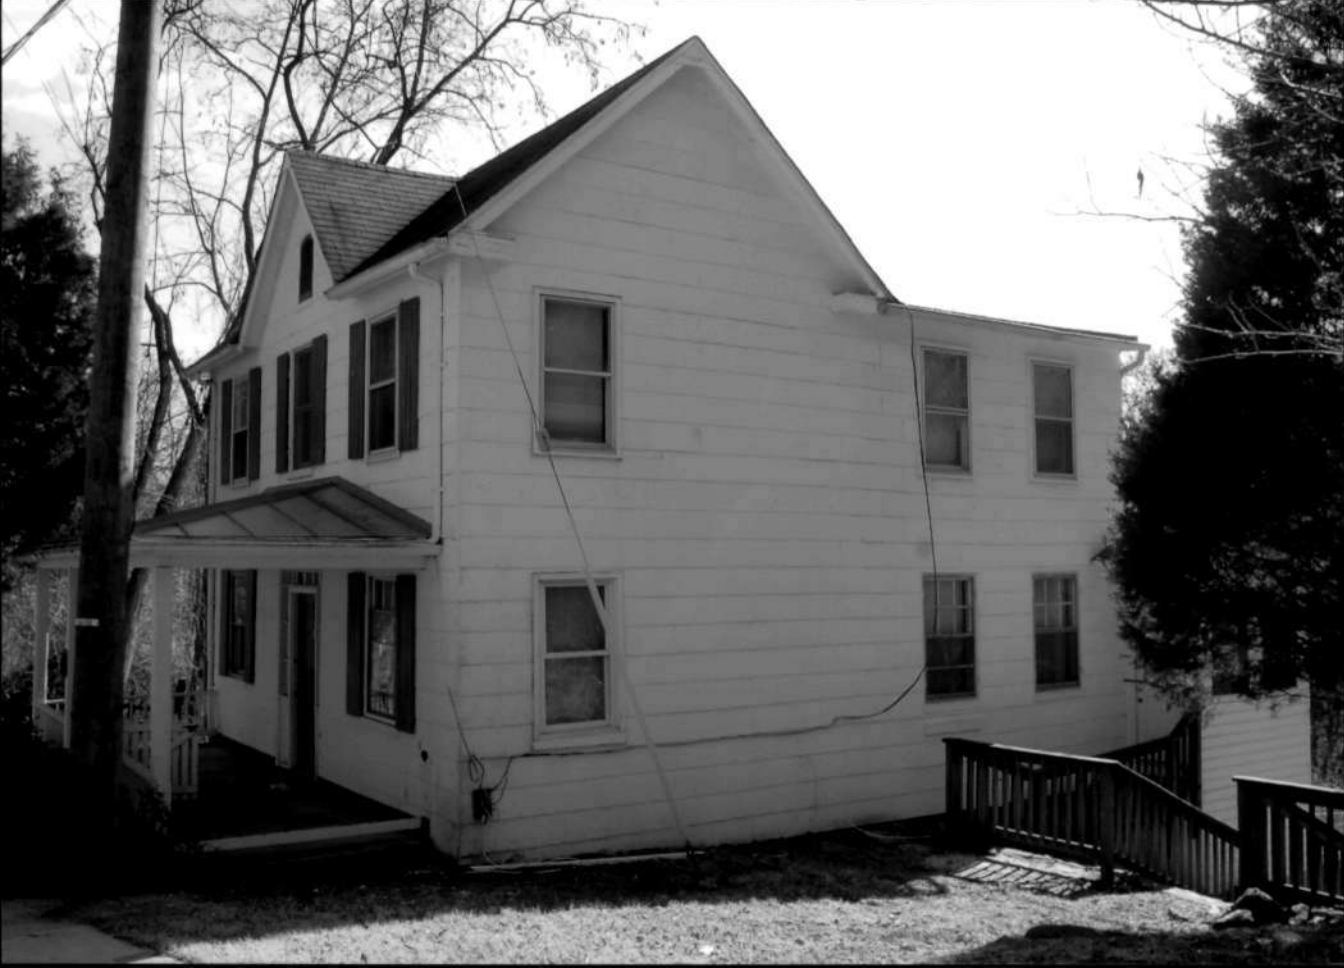
2 of 7

Northeast & northwest elevations

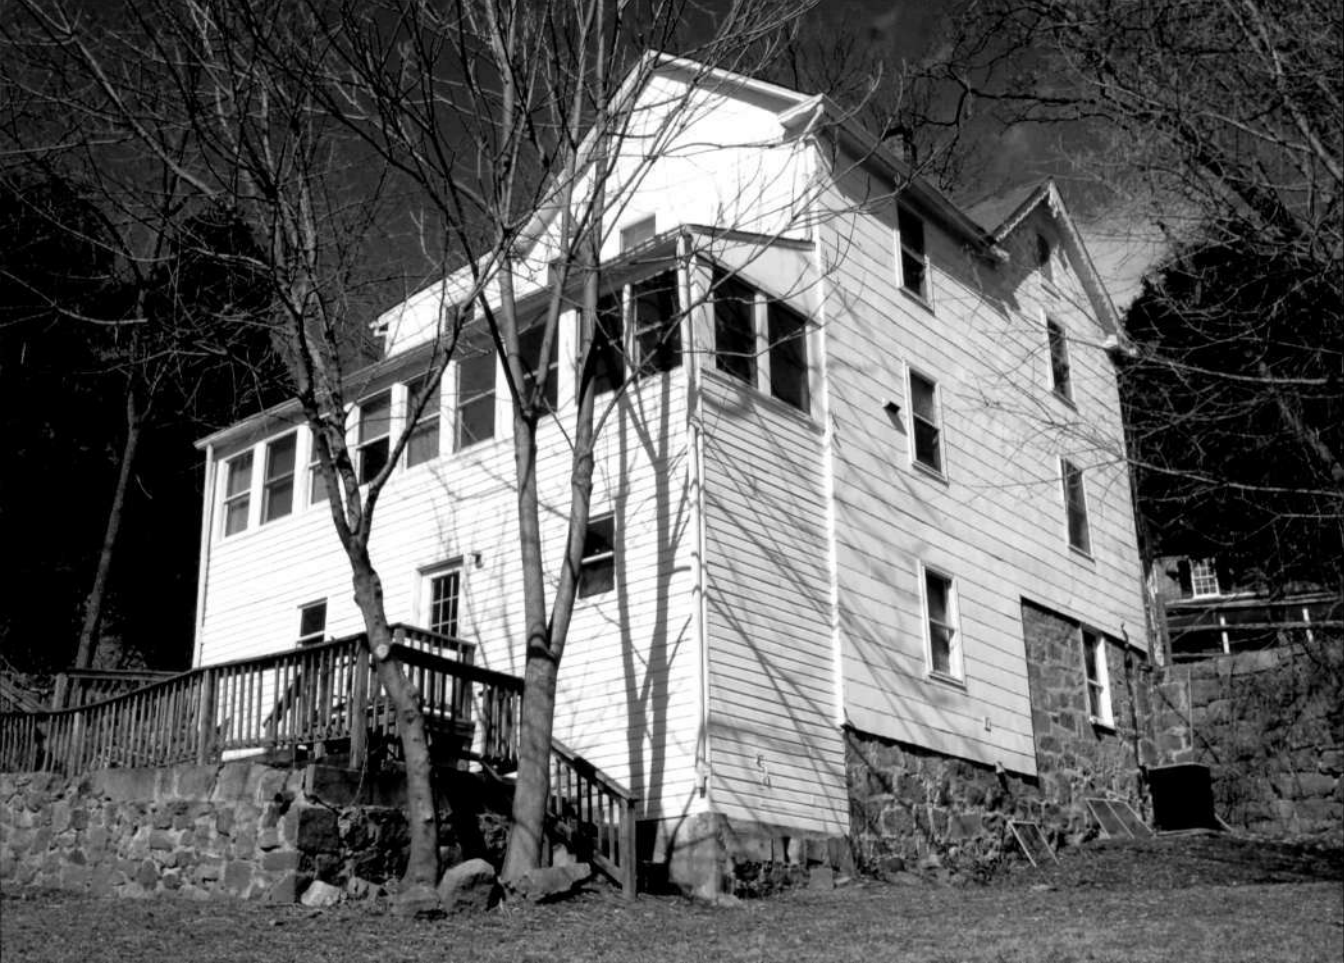
3 of 7

Southwest & Southeast elevations

The southwest elevation has nine one-over-one sash on the first story of the enclosed porch. The second story of the addition has a one-over-one sash in a new frame and the ell has a one-light sash with infill below it set to the west and a one-over-one sash in the center of the second story. There is a piece of sawn bargeboard on the return of the ell. The southeast elevation has a stepped stone foundation with the ell foundation mostly being frame and having one new one-over-one sash. The main block foundation is all stone with a one-over-one sash that has been altered and was originally a nine-over-six sash that was mortised and tenoned and pinned. This window opening has a large bead on the frame. The first and second stories of both the ell and of the main block each have a new one-over-one sash. The gable end of the main block has a segmentally-arched louvered wood vent. There is jig-sawn bargeboard with a drop pendant in the center at the ridge.

The original southwest exterior wall of the house cellar is now covered by the enclosed porch, and is rubble stone with some roughly squared stones and some brick at the top. The outer face of the wall does not extend all the way up to the ceiling of the porch, and there is stone wall behind it, as if the outer face was added to strengthen the wall behind it. There are some drill marks in the stone and there are quoins at the corner. The stone is on the west and center bays, while there are weatherboards on the south bay. The south bay has a doorway with a beaded-interior-edge frame, and the door has beaded-edge vertical boards with a four-light sash in it. The sill is a piece of window jamb with two rabbets in it that once held stops. The door has a cast iron Suffolk latch and a slide bolt, and is hung on cast iron butt hinges with five knuckles and heavy paint buildup. There are rooms under the south and east corners of the house only. The east cellar has a stone and brick wall on the southwest. There is a furnace here that vents into the chimney in the east room. The joists above are sawn and painted, are 2-1/2 inches by 8 inches, are spaced 20 inches on centers, and run northeast-southwest. There are single boards nailed between the centers of the joists for bridging. The cellar floor is mostly concrete but has some boards in it. The south cellar has drywall and a tile floor, but there is a hole in the ceiling that shows that the original room was lathed and plastered. The first-story joists are sash-sawn, run northwest-southeast, and are the same size as the east cellar. The northeast wall is partially built on bedrock.

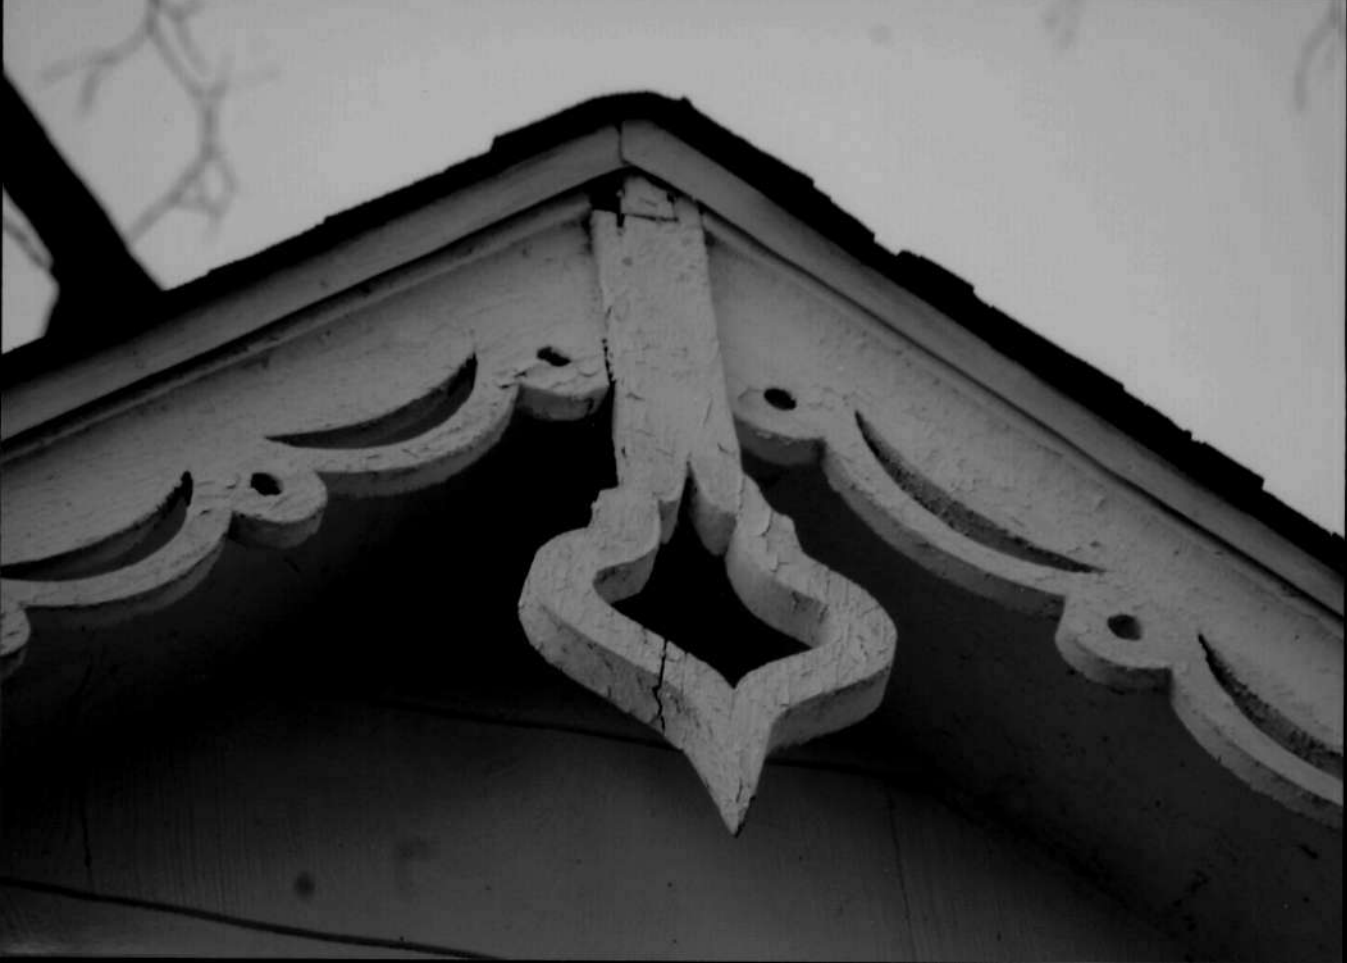
4 of 7

Southeast elevation, gable end  
bargeboard

bargeboards with pendant drops on the eaves. These gave a touch of distinction to what was otherwise a rather simple, plain structure, and probably also served as an advertisement for Robinson's abilities as a carpenter. The cross gable on the front was also stylish for the 1860s, though at this point it has not been determined whether this was an original feature or, like so many others, was added later. Perhaps most unexpected about the house is that it was built for central heating from the beginning, and the existing radiators could be the originals. In Baltimore City central heating was becoming fairly common for new construction for middle class housing, but it was not at all common yet in rural towns. Given that he was a builder, Robinson was probably not only more familiar with the systems than the average homeowner, but had probably become comfortable with them and their operation and reliability. The Robinson House, then, is an important dated example of the taste of middle-class artisans right after the Civil War, and illustrates how they worked within the system to finance such a building.

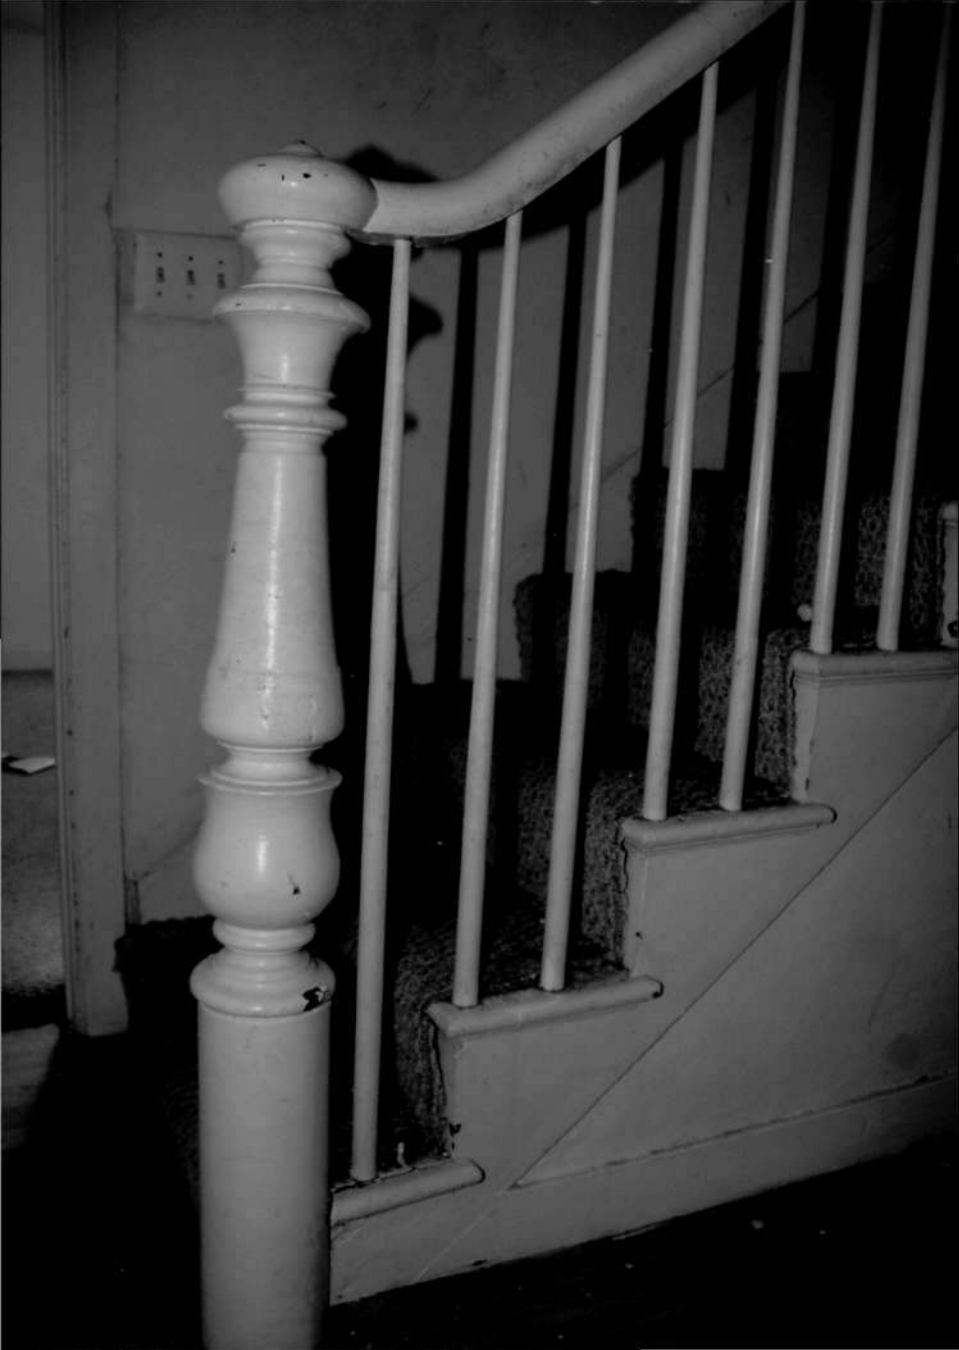
5 of 7

Center passage stair newel

The house was traditional in room arrangement and detail, and moderate in size, with a center passage flanked by one room on each side, and a kitchen and small room in the rear ell. Several features of the house are of note. The turned newel post is of the Greek Revival "urn" profile that was popular in the 1840s and early 50s, but was passing out of style in the 1850s for larger, more robust and angular newels. However, as has been seen in other lower and middle-class houses in Howard County, this retarditaire newel remained popular, either because of conservative taste or because it was more affordable. Judging from the mantel piece in what was probably the dining room, the later was the case. The mantel is of wood and is simple, with a large cartouche in the center of the frieze. The form was popular in marble among the wealthy in the 1850s and 1860s, and was copied in marbledized slate and marbledized wood in this period by all classes. This is a wood version that was probably marbledized originally, and in addition has decorative jig-sawn edges and a deeply cut mantel shelf. These touches were probably added by Robinson as his own personal signature. In a similar vein are the jig-sawn

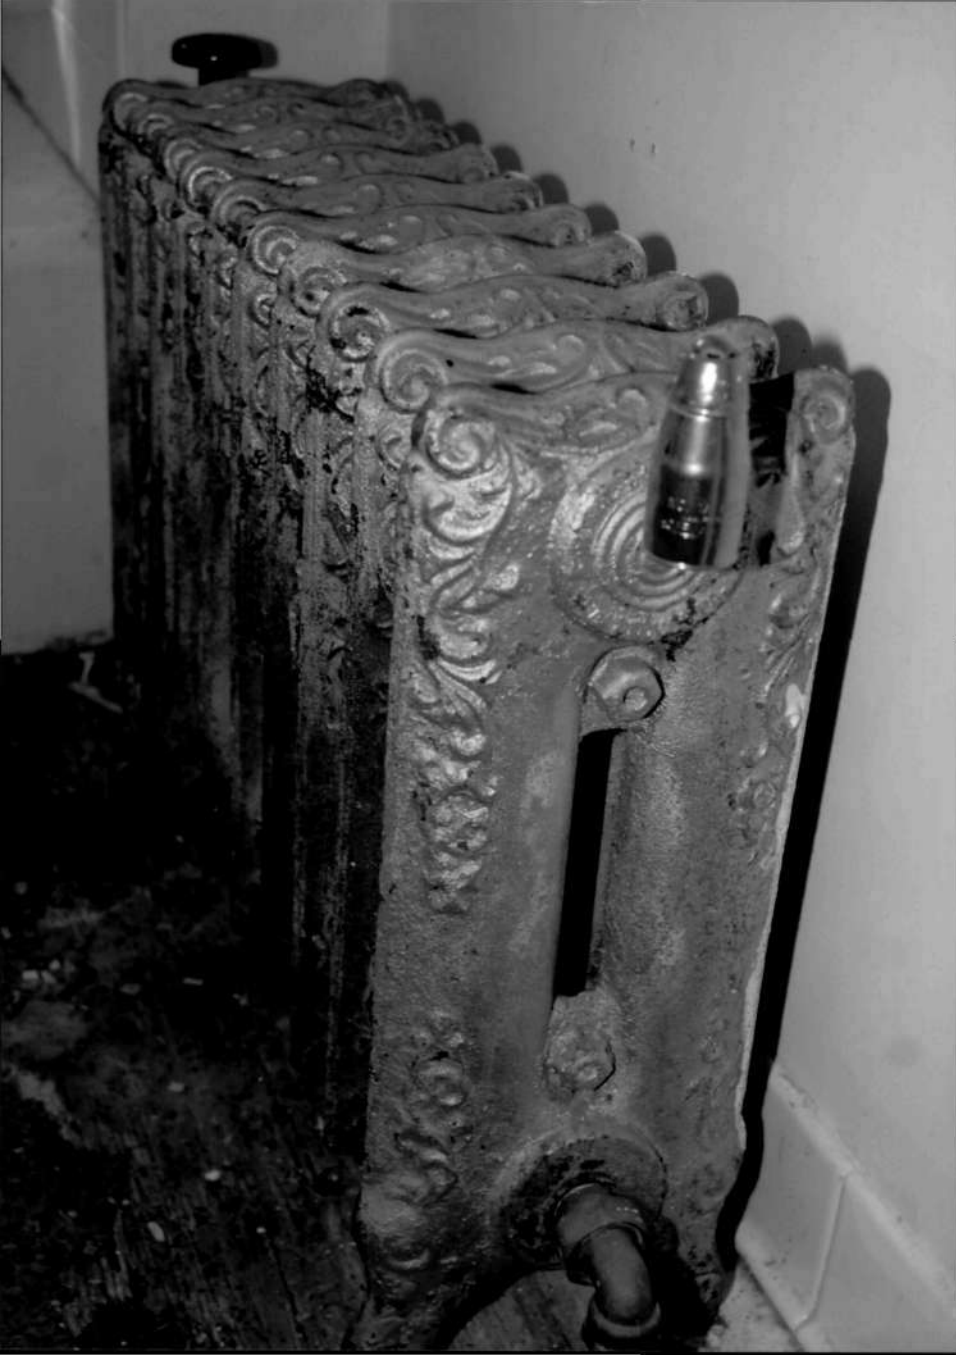
6 of 7

Center passage radiator

The first story has a center-passage single-pile plan with a vestibule and two rooms in the ell, a single room in the addition, and an enclosed porch across the rear elevation. The passage has linoleum on the floor, plain baseboard, plaster on lath, and some drywall. Most of the architrave is new, and all of the doors are new. The front door, sidelights, and transom have all been replaced. The front door architrave is original, is side-cut, and has a beaded interior edge. There is a two-run stair on the southeast wall that ascends to the southwest, where there is a landing, then turns to the northeast and the southwest into the ell. The stairway has a plain open stringer and a turned newel post that is a slender Greek Revival urn type. There are round, tapered balusters and an ovoid handrail. The newel and handrail were originally stained a dark color. There is textured plaster on the ceiling. A doorway under the stairway leads to a closet. The northwest wall has a cast iron foliate radiator.

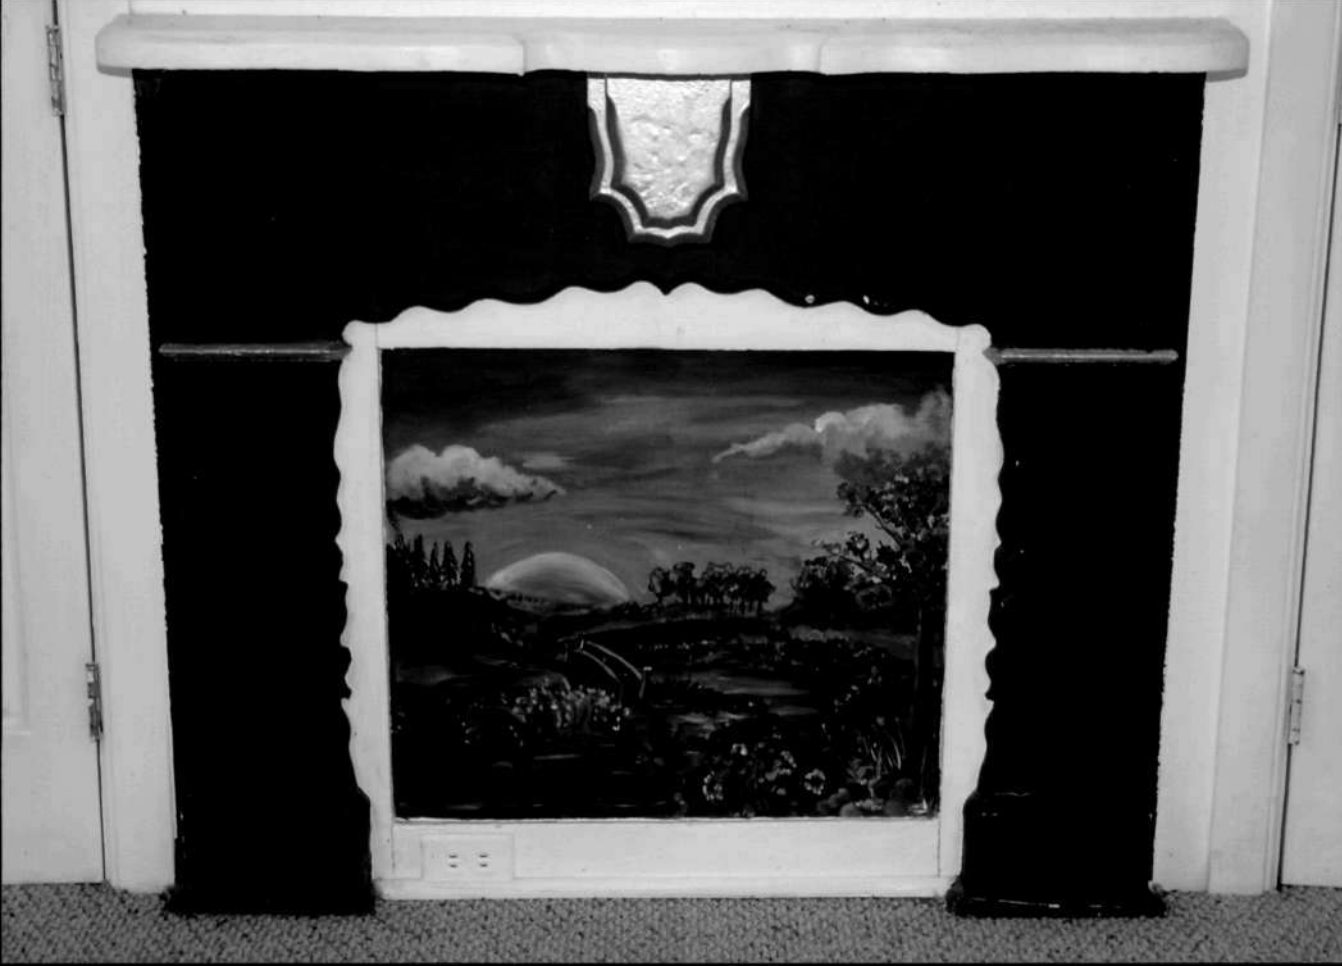
7 of 7

South room mantel
